# Home Builds Part 7

A small-bore Bultaco road burner, restored to a showroom shine

BY MIKE McNESSOR • PHOTOGRAPHY BY ALAN SINGER

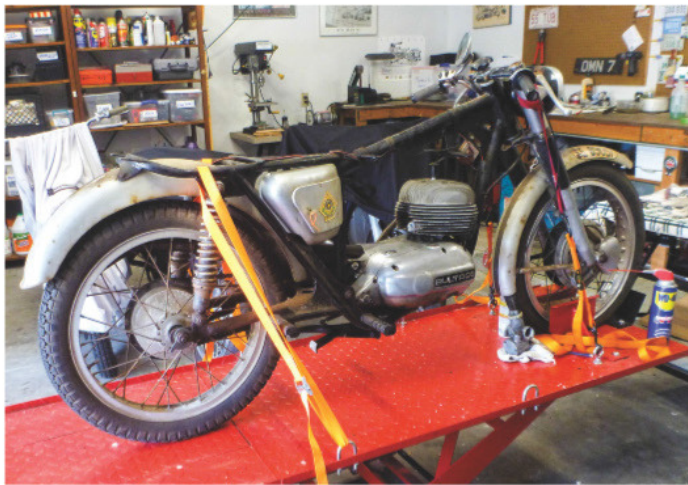
The teardown began shortly after the bike arrived. The Bultaco's 200-cc two-stroke wasn't running at the time, but the odometer showed just over 5,000 kilometers (about 3,100 miles), so chances were good that it wasn't totally worn out.

Alan tore the bike down and sent the two-stroke engine out for rebuilding. It required very little machine work, however — the cylinder was honed and a new set of rings was installed. Alan painted the chassis and spent hours polishing out all of the bike's corroded aluminum bits. The tank and body work were sent out to a professional painter for refinishing and to a pinstriper, who carefully recreated the factory stripes. New wheels and tires, mirror-like plating on the exhaust, and a saddle recovered in the original-style upholstery helped make the bike present like showroom-fresh.

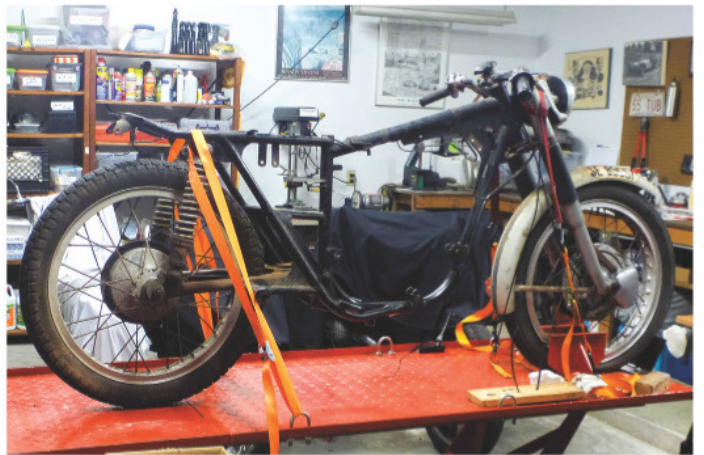
Here, with the engine out of the chassis, and the tank, side cover, and rear fender removed, the simplicity of the Metralla's frame is even more evident. Basic stuff: steel tubing, with sheetmetal gussets welded in, but still a strong and rigid foundation.

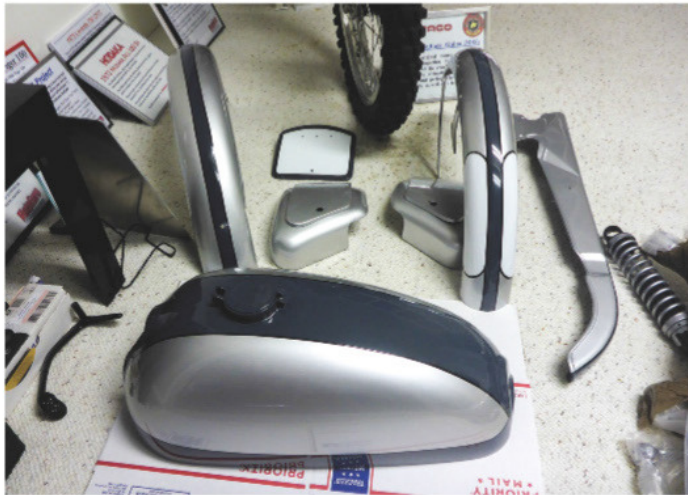
The Metralla's 3.4 gallon tank and body panels are pictured here fresh from the paint shop and the pinstripes are looking as good as new. Fortunately, the parts were in reasonably good shape to begin with so a lot of body work wasn't needed.

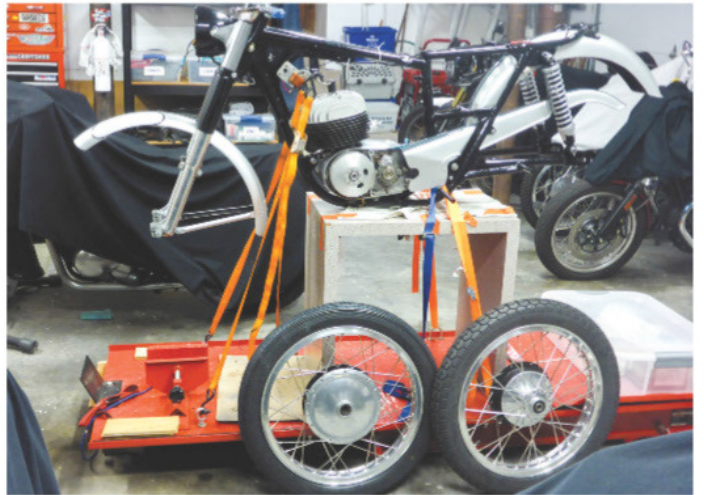
The Bul is starting to take shape with the rebuilt engine back in the refinished frame, the reconditioned forks and shocks in place, and the fenders, as well as the chain guard, bolted on. New wheels were laced up and shod with fresh rubber.

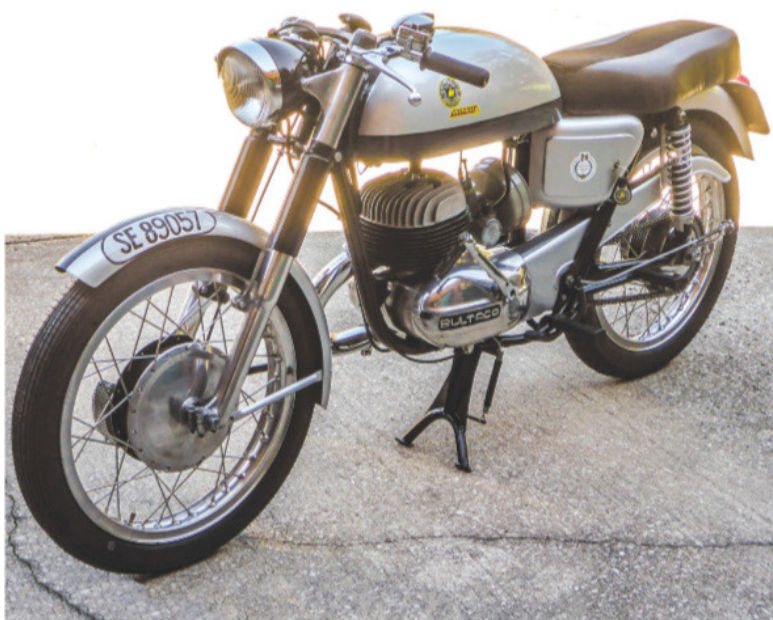
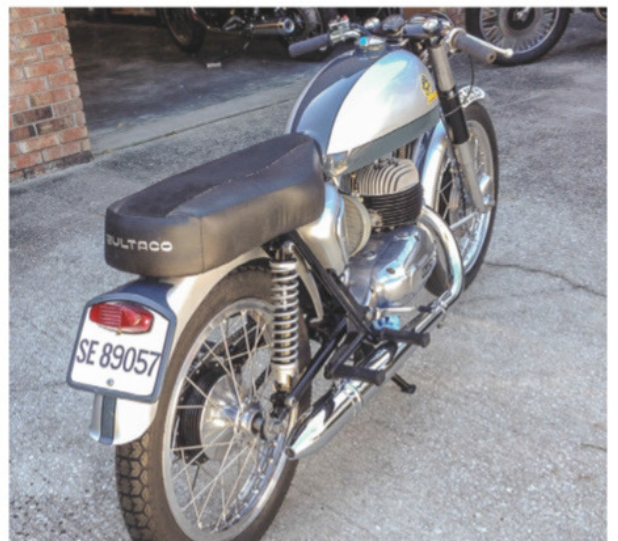
Just one year after the project began in 2016, Alan rolled the Metralla out into the driveway for its closeup complete with its Spanish license numbers. That reupholstered saddle looks pretty inviting to us.
